McLaren Doors Diagnostics – Door difficult to operate / cables come off

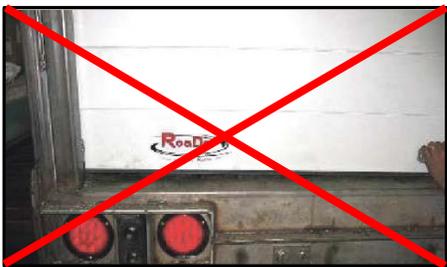
Wrong

Door is not level – high on one side. To correct: Close the door and gently loosen the cable drum on the high side until the door is level. Re-tighten the fasteners securely.

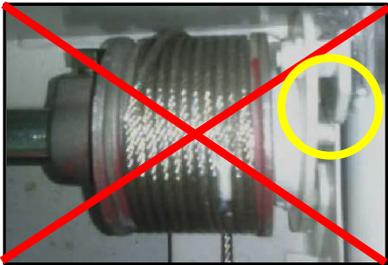
Wrong

<p>Picture shows the shaft contacting the angle. You should not see the shaft in this gap. This would cause friction impeding door operation and possibly causing you to add spring winds to over compensate. This will also cause cables to dislodge.</p>

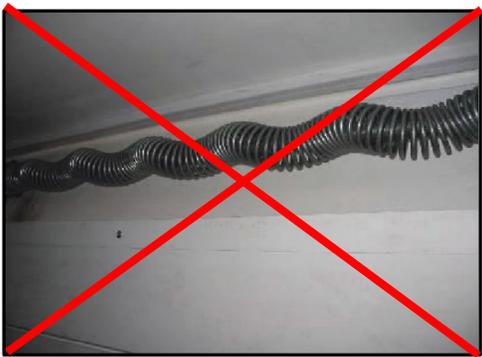
Correct	Wrong

Problem Symptoms: Door becomes increasingly difficult to close as it nears the bottom / and could be very noisy.

Ensure the spring is straight when closed. If it is not, it will need to be adjusted. Refer to our spring winding instructions available on our website, www.mclarendoors.com – installation section or contact us toll free at 1-877-263-9153
