McLaren Doors Diagnostics – Door difficult to operate / cables come off

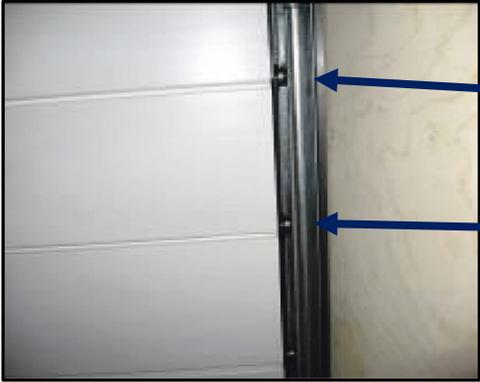
Correct

<p>This is the best method to check for an installed door:</p> <p>You should be able to place a finger on the black side straps where the roller goes through them and be able to wiggle them side to side, (no more than 1/8").</p> <p>Important: Check both ends of the panels and in several places; Between the Vertical tracks, and with the door open. between the tracks in the Radius and between the horizontal tracks. Often we find the tracks narrow in the radius.</p> <p>If they are tight this will be a source of friction causing the door to operate less than optimally. This should be adjusted. First try an adjustable load bar to see if you can push the tracks out. If that doesn't work, contact McLaren Doors and we will be able to provide you with additional suggestions.</p>

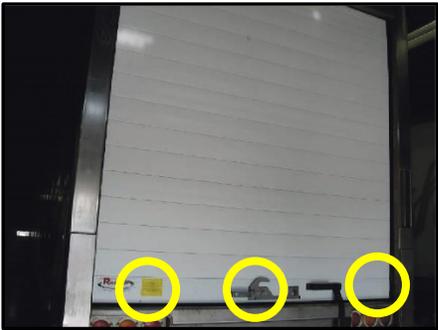
Correct

Door is level.

Bottom seal is making good contact across the sill. If it is not, it will cause the door to go up at an angle, creating friction

Top panels should be aligned straight up and down with the rest of the door panels and the top seal is making good contact.

If not the top roller brackets require adjustment; move them down to tighten the seal or if the panels are pushing outwards making the door difficult to close, move the brackets up. See picture below for more details.

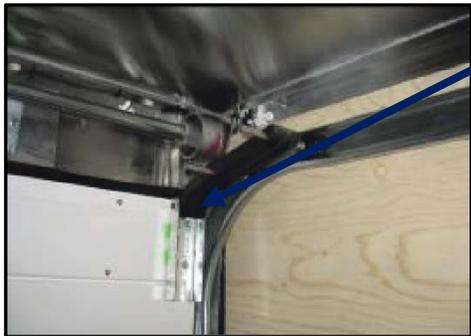
Correct

For most doors the top of the silver bracket will be + / - ¼” from the top of the door. The top roller brackets should be secure and parallel with the tracks, in from the panel edge by ¼”.

- If the door is leaning out on the outside, the brackets are too tight and should be loosened by moving them up slightly.
- If door is leaning in or you do not have a good seal across the top, move the bracket down slightly to tighten.

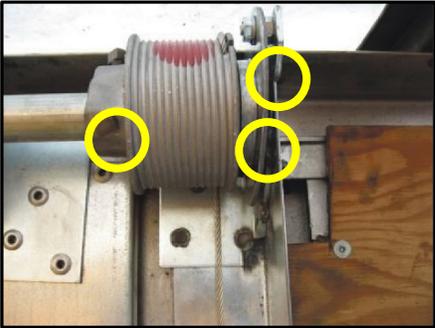
Correct

<p>End of the shaft must not be in contact with the metal side angle. Space between end of the shaft and the vertical track side angle is visible through the gap.</p> <p>If the shaft is contacting the vertical track angle and not turning freely it will make the door difficult to operate and / or it will cause cables to come off frequently.</p> <p>Ensure the shaft is centred looking through the gap on both sides. If it is still making contact you may need to adjust the shaft length. Make sure you have first tried to centre the shaft before you cut. If the shaft is cut too short it will dislodge causing damage to the door and potentially injury.</p> <p>Ensure cable drums turn freely and are not contacting the roof or header. Cable drums in contact with the header or roof limit their ability to turn freely. This will interfere with door operation and will cause cables to come off.</p> <p>Cable drums must be pushed fully to the outside, riding against the bearing, to secure the shaft in place. Fasteners securely tightened. The fasteners should be turned one revolution after making contact with the shaft surface. If they are not secure, the cables can come off the drums.</p>

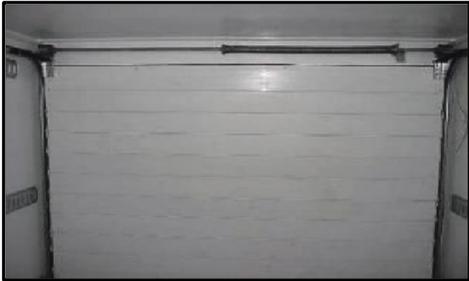
Correct

<p>If the shaft is not level this will cause torque on the operator and may make the door more difficult to operate plus it will cause premature wear on the operator.</p> <p>The location of the centre shaft bracket is usually the cause. If the bracket is too low it may also cause the door to bump against the operator when first opening it.</p> <p>To correct this you need to relocate the shaft bracket so it is aligned between the end brackets.</p> <p>If none of the above, then the top panel could be too high. In this case, call McLaren Doors for assistance.</p>

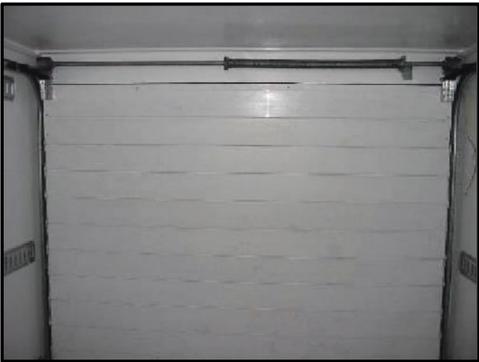
Correct	Wrong

Ensure the spring is straight when closed. If it is not, it will need to be adjusted. Refer to our spring winding instructions available on our website, www.mclarendoors.com – installation section or contact us toll free at 1-877-263-9153

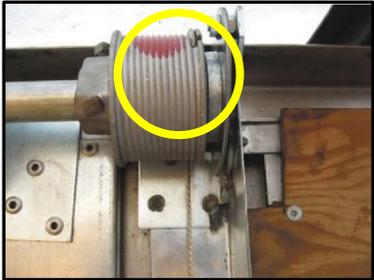
Correct

<p>Checking the height of the end shaft brackets:</p> <p>Measure from the bottom of the vertical track to the top of the bearing bracket, (shown at the left).</p> <p>That measurement should be 6" or more greater than the opening height</p> <p>If you believe this needs to be adjusted contact McLaren Doors to discuss the optimal solution</p>
